Mobile Intel® Pentium® III Processor and Mobile Intel® Pentium® III Processor-M

Specification Update

March 2006

Version 053

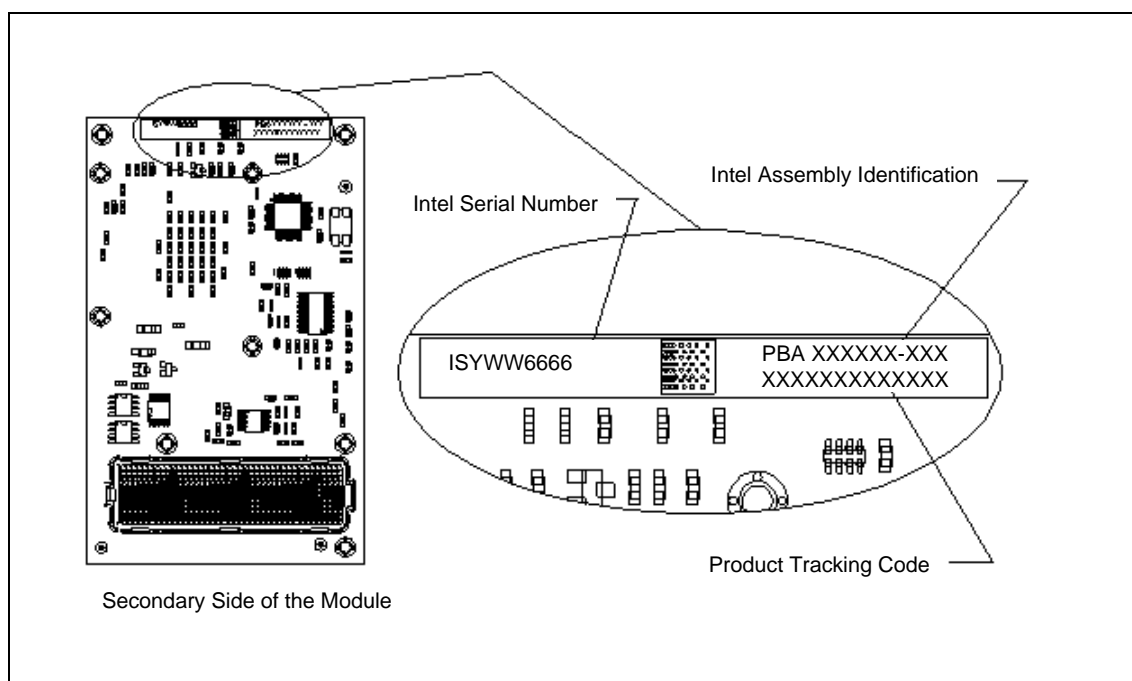
Intel® Pentium® III Processor Mobile Module Markings

The Product Tracking Code (PTC) shows the assembly level of the module. The PTC is on the secondary side of the module and contains 13 characters. See the example below:

For other Intel Mobile Modules, the second field (B) is defined as:

Pentium® II Processor Mobile Module (MMC-1)	= D
Pentium® II Processor Mobile Module (MMC-2)	= E
Pentium® II Processor Mobile Module with On-die Cache (MMC-1)	= F
Pentium® II Processor Mobile Module with On-die Cache (MMC-2)	= G
Celeron® Processor Mobile Module (MMC-1)	= H
Celeron® Processor Mobile Module (MMC-2)	= I
Celeron® Processor (.18μ) Mobile Module (MMC-2)	= N
